POL PIER REPAIRS LAJES FIELD AZORES(U) OLKO ENGINEERING 1/1  
NEW YORK FEB 83 CHES/NAVFAC-FPO-8365.2  
DACA51-79-C-8123

POL PIER REPAIRS  
LAJES FIELD , AZORES

FINAL FIELD INSPECTION REPORT  
FEBRUARY 1983

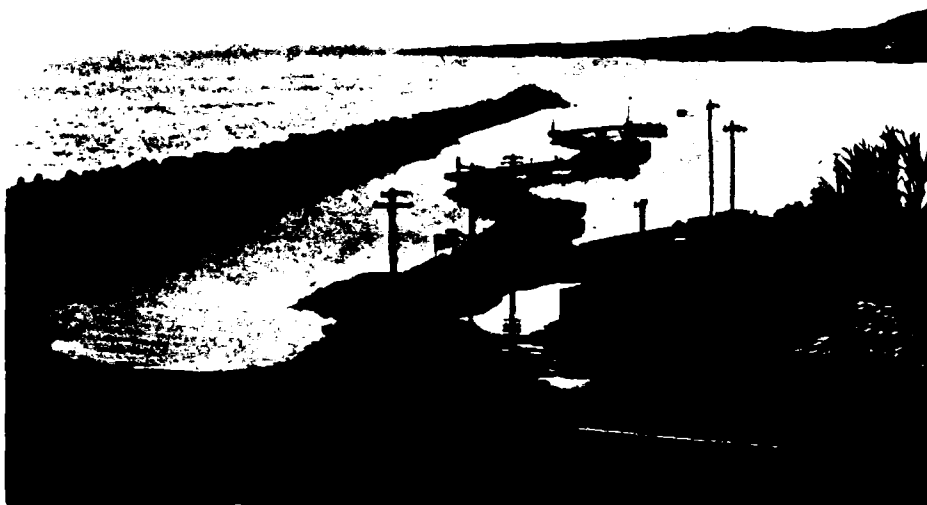
Photo  
No. 1

General views of existing POL Pier complex - Looking southward at Praia Bay, the Breakwater and the Pier facilities which consist of a Central Loading Platform, Mooring Dolphins, Roadway and Catwalks.

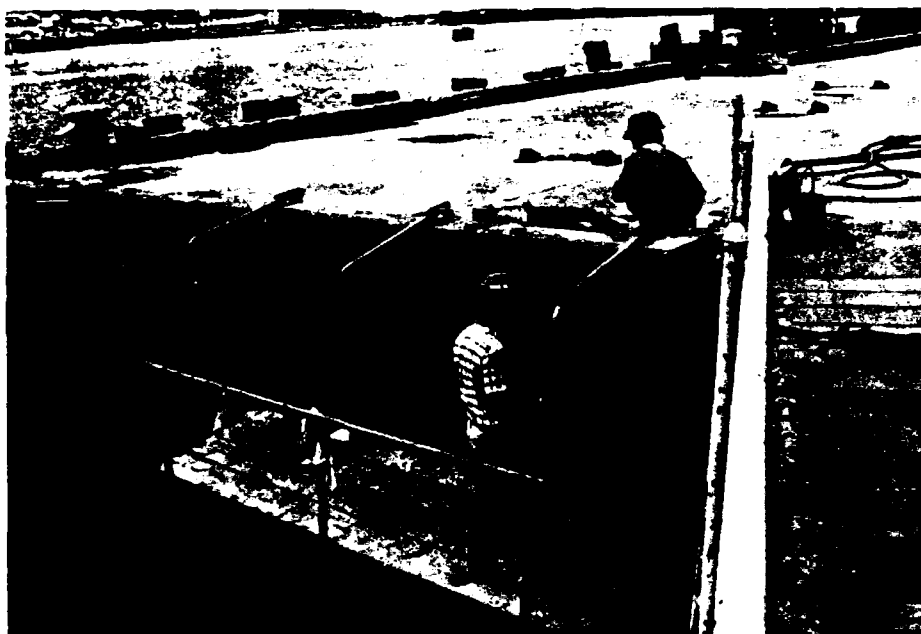
LOADING PLATFORM - SOUTH END  
Installing Bolts to Tie-In the Template for the New  
South Dolphin.

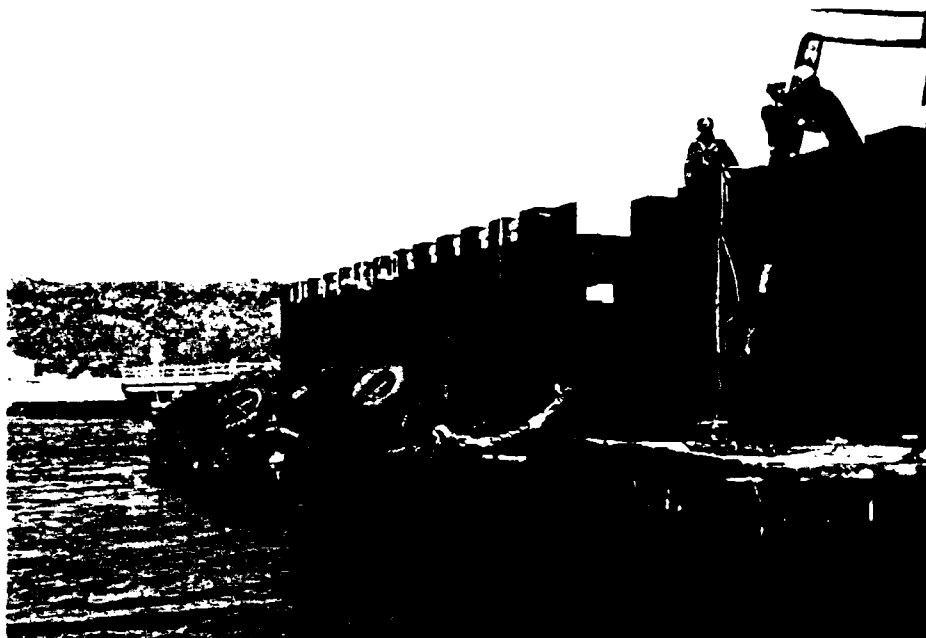
#### LOADING PLATFORM - TIMBER FILLER

Placing Timber Fillers, Between the Sheet Pile Flutes, at the North End of the Loading Platform, to Form a Flat Bearing Surface for the Floating Fender Units.

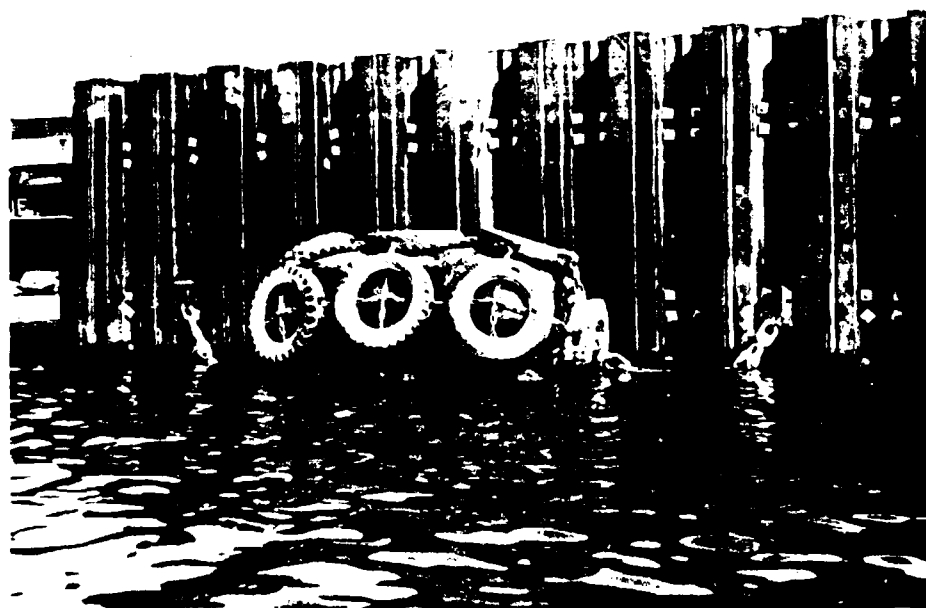
#### SEA CUSHION FENDER

Temporary Tie Up at the New North Dolphin. Note Wire Rope Temporarily Serving as a Shackle, to Connect the Chain to the Sheet Pile Pad Eye.

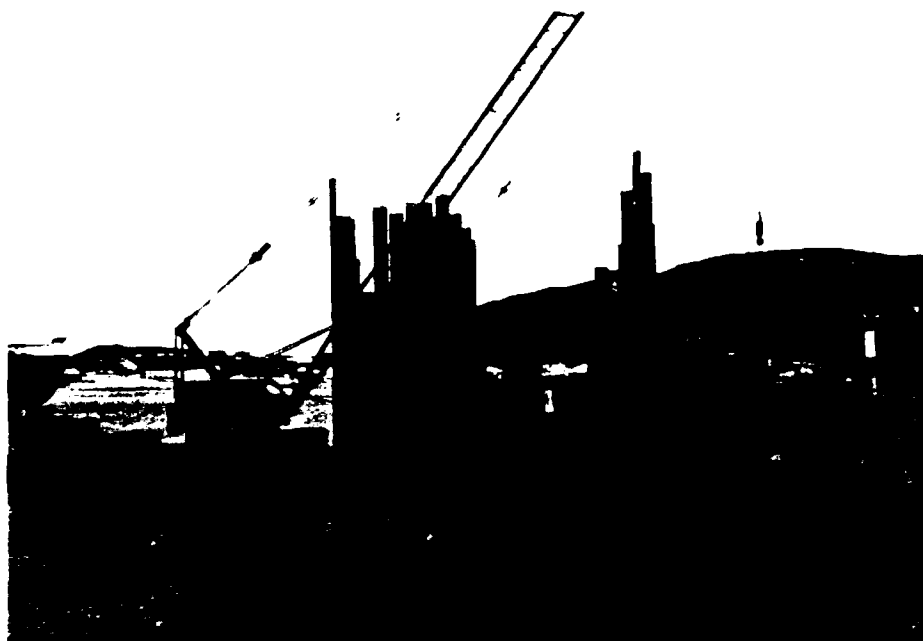
#### NEW SOUTH DOLPHIN

Overall View, Looking North. The North, East and South Walls Are Partially Driven. The South End of the East Wall Is "Hung Up" on an Obstruction About 5 Feet Below the Harbor Bottom.

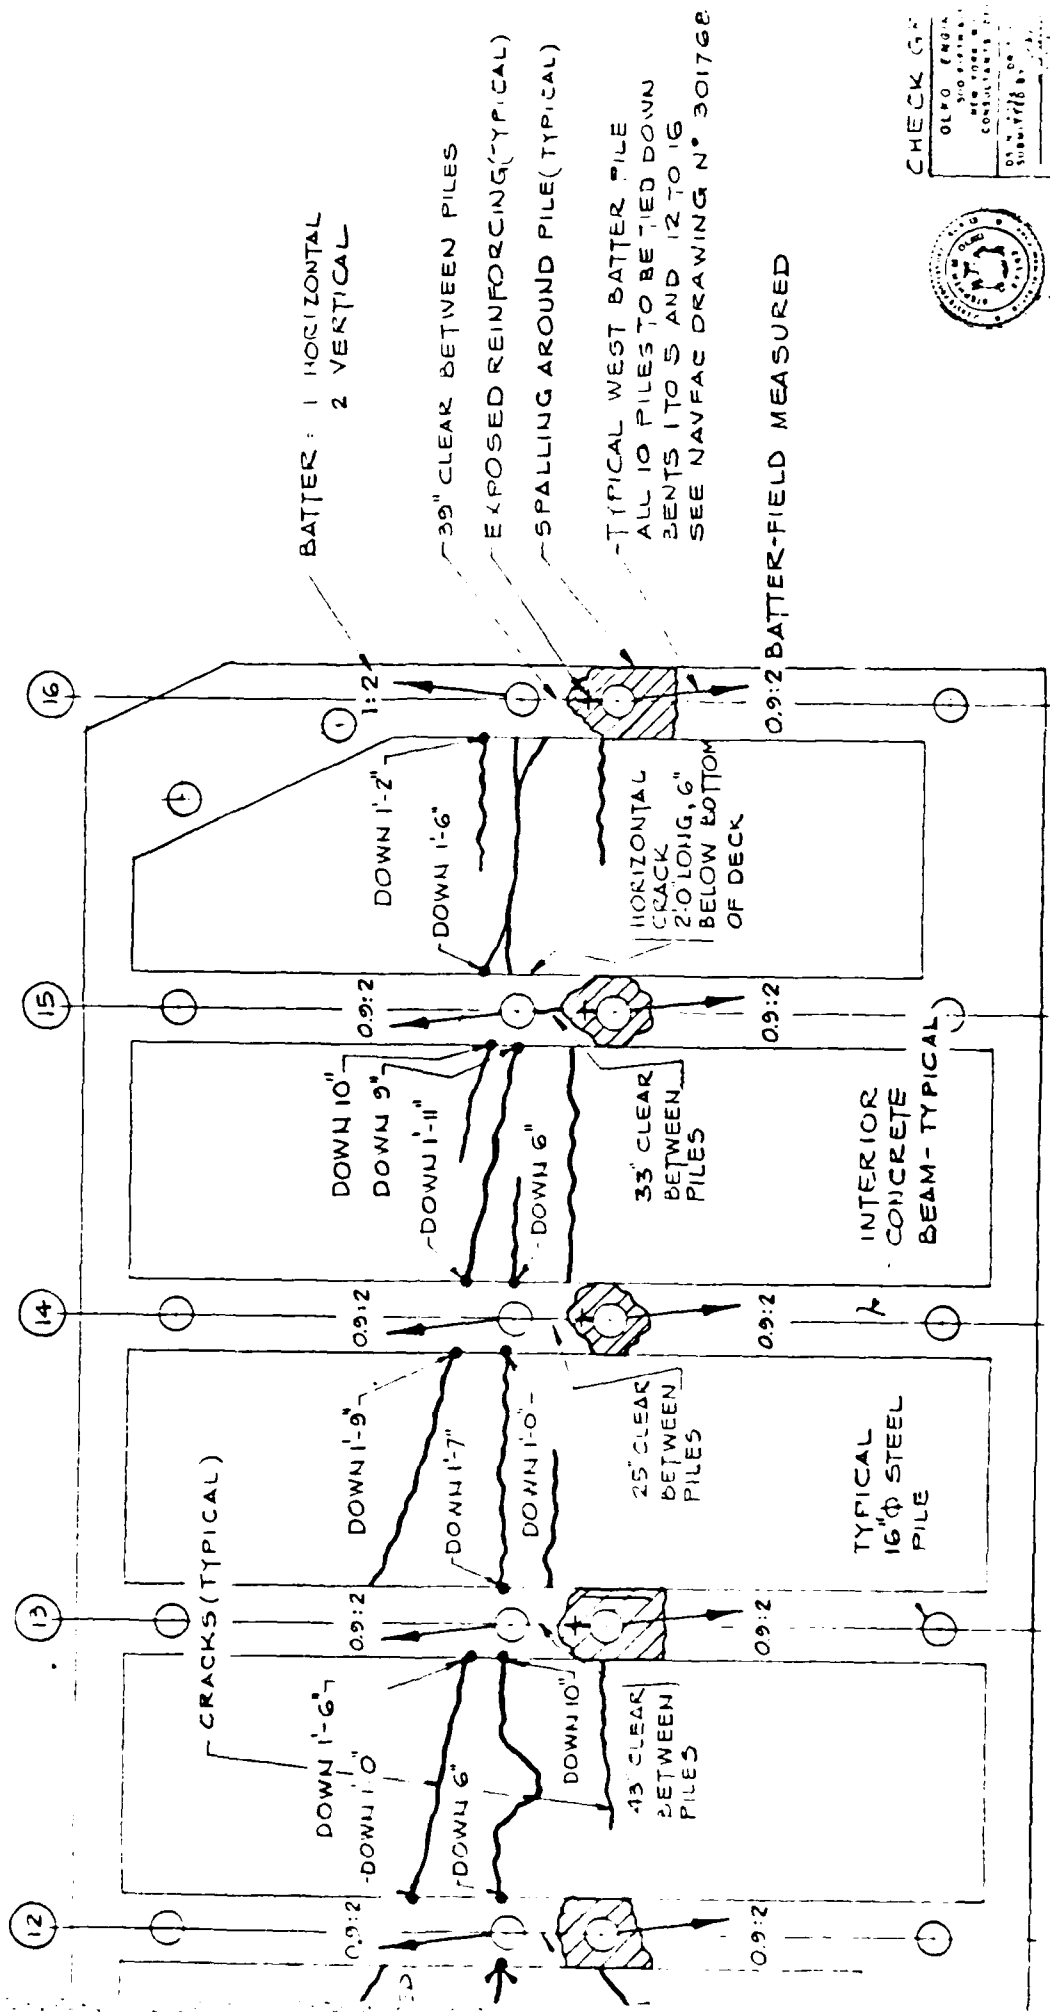
PLAN - SOUTH END  
CRACKS - UNDERSIDE OF CONCRETE DECK

Loading Platform Grouting of Cracks: Epoxy grout all deck & beam cracks at the south end of the Loading Platform.

Accordingly, it appears that even the fine hairline cracks, can be pressure grouted, using a nonviscous epoxy suitable for this purpose, as specified. The work will proceed on this basis.
